St Stephen's Church, Winsham

QUINQUENNIAL SURVEY INSPECTION AND REPORT ON ST STEPHEN'S, WINSHAM

November 2006

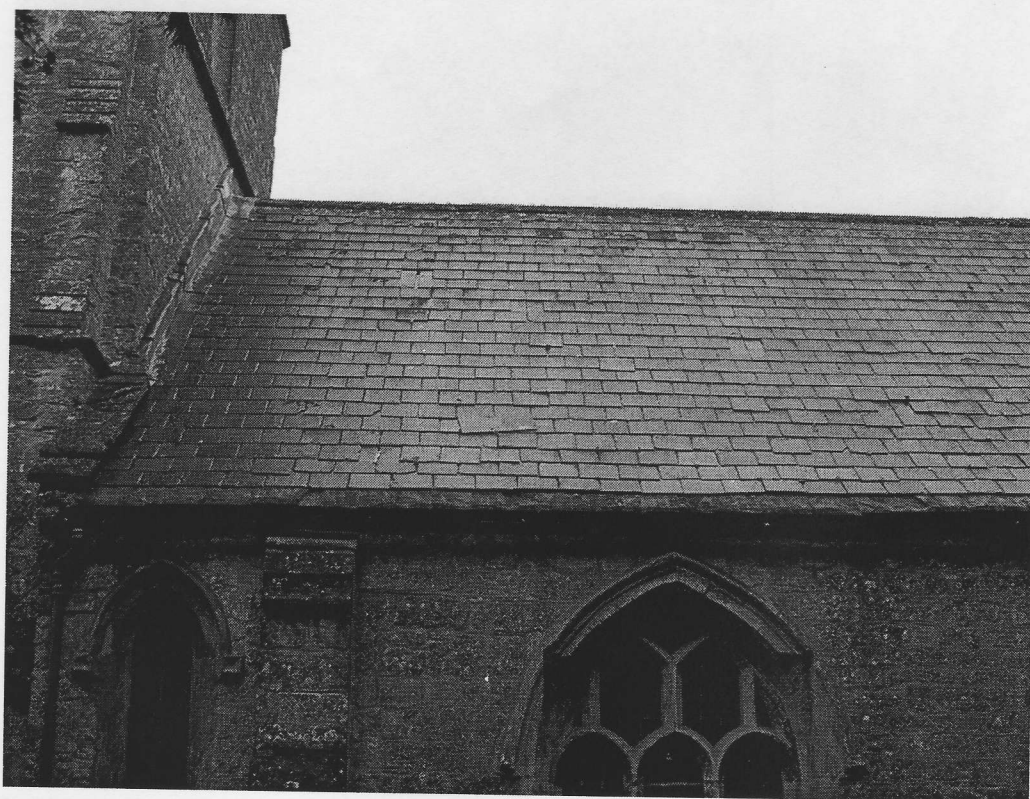
- 3.5 There are at least three missing slates on the nave south slope, one slipped slate and several broken slates. At least 14 slates have been fixed with tingles on the nave north slope there are four slipped slates and numerous slates have been refixed

- with tingles. The condition of the slate nails needs to be inspected to determine the life of the roof but in view of the fact that patch repairs have been undertaken since the last quinquennial inspection and given the number of slipped, missing and broken slates it is assumed that the fixings are reaching the end of their life and that reslating is required. M1
B1
F1

Nave north slope -- slipped/missing slates.

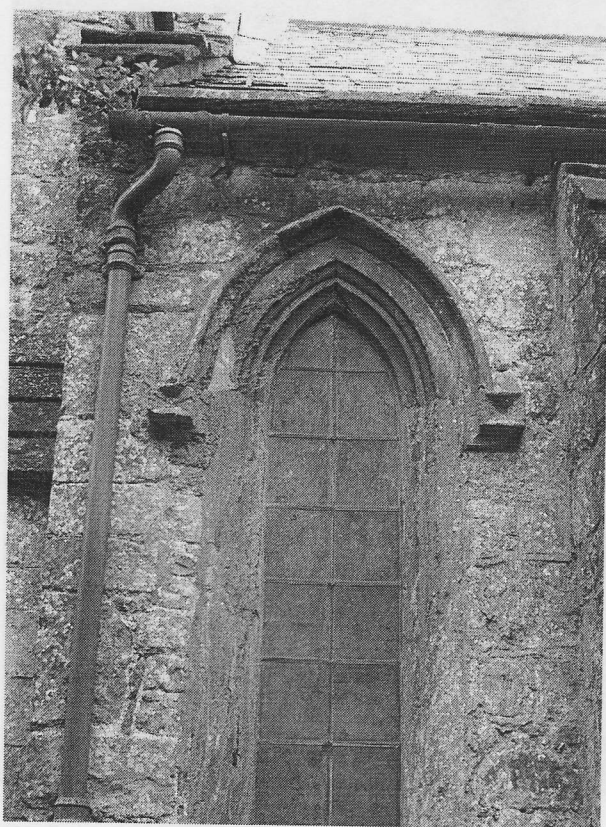
- 4.1 Gutters are generally of cast iron half round sections. The chancel south gutter west of the downpipe has a backfall and the guttering is leaking from the joints. The chancel north gutter undulates, is ponding and plant growth is occurring. One gutter length is cracked. The nave north gutter is set well below eaves level at the high point which means that the roof discharge may overshoot the gutter. The gutter does not fall evenly to the outlets. The nave south gutter appears to have a backfall at the eastern end. There are no gutters to the porch. A complete overhaul of the guttering is required. B3/
M4

Nave north elevation -- plant growth from gutter.

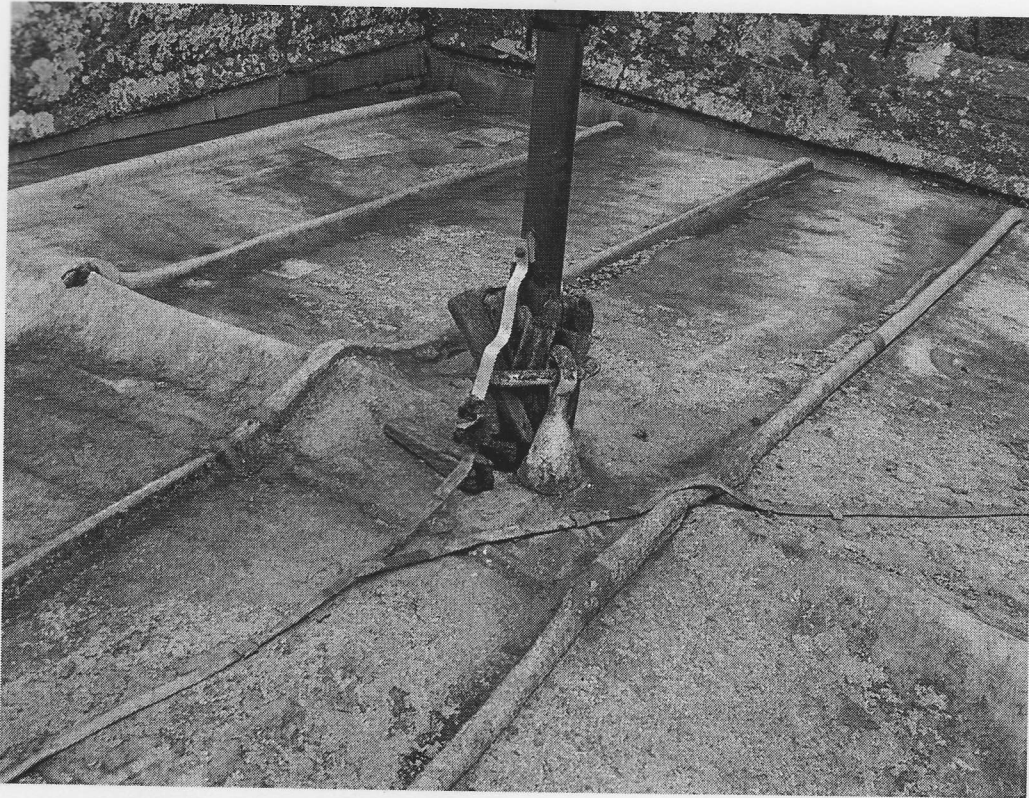
- 3.13 At the centre of the roof there is a flagpole which appears to sit on timber blocks. The ridge does not continue through at this position and the central sheets are soldered together at the lap. There is a split in the lead on the north side of the flagpole – previously lead burnt and split again. Patch repairs need to be undertaken until the detail can be modified. M3/
C2
- 3.14 The cover flashings to the west gutter have split. M3/C
2
- 3.15 The roof of the tower vice is covered with concrete (unprotected) and discharges on the eastern side via a small stone spout projecting only about 5" from the wall face. There are old fixings in the concrete roof for a weathervane (removed prior to 2001). C2

Leadwork to tower roof at base of flagpole.

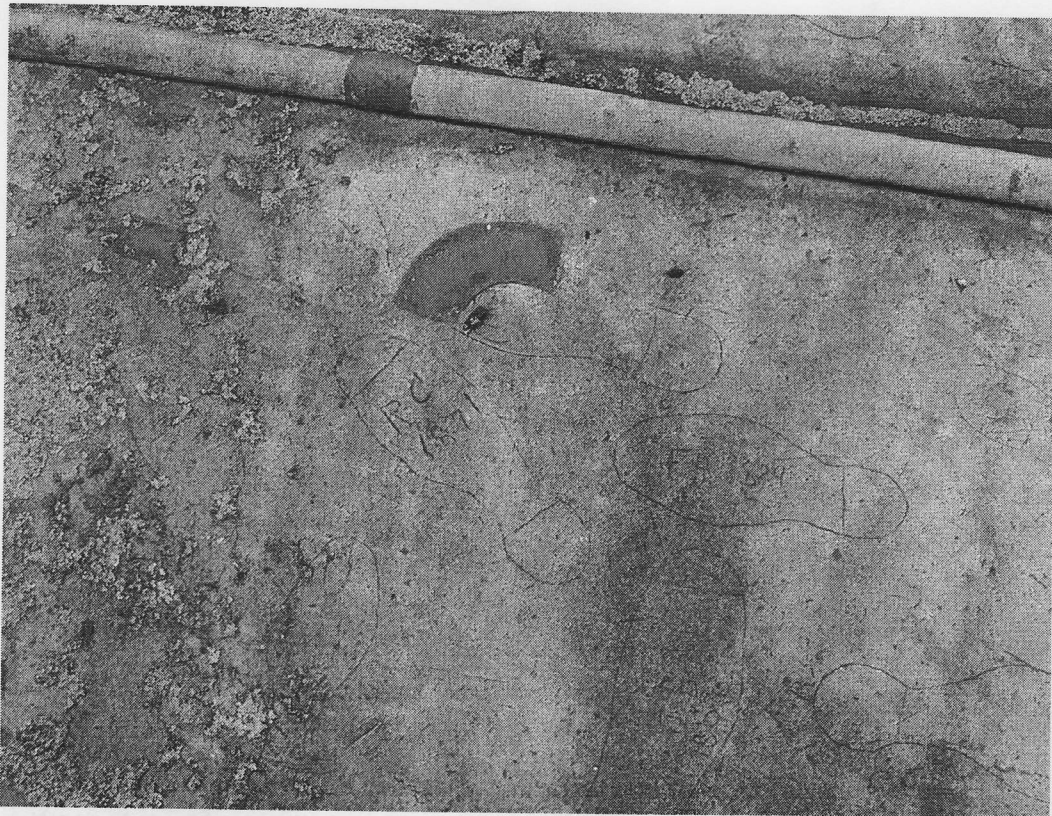
- 3.12 There are numerous splits or cracks in the lead – generally at the seams. Patch repairs need to be undertaken and are likely to be required on an ongoing basis. It may be appropriate to consider repair/recovering of the roof when the tower is next scaffolded. M3/
C2

Graffiti on tower roof leadwork and previous patch repair

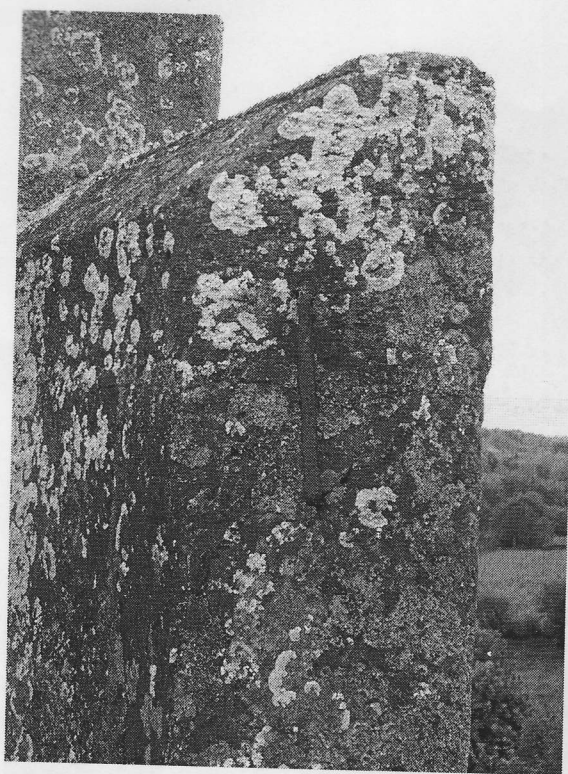
- 5.1 The parapets of the tower and of the vice are of Ham Hill stone (or similar) and are secured with wrought iron cramps on the inner and outer faces of the parapets. There is some corrosion and fracturing noted in a few stones. Some of the iron cramps are no longer securely anchored into the stonework. Corrosion and resultant expansion of the iron is likely to cause further fracturing of the stonework. The situation needs to be kept under review. F2/
C3

Tower parapet – iron cramp and fractured stone.

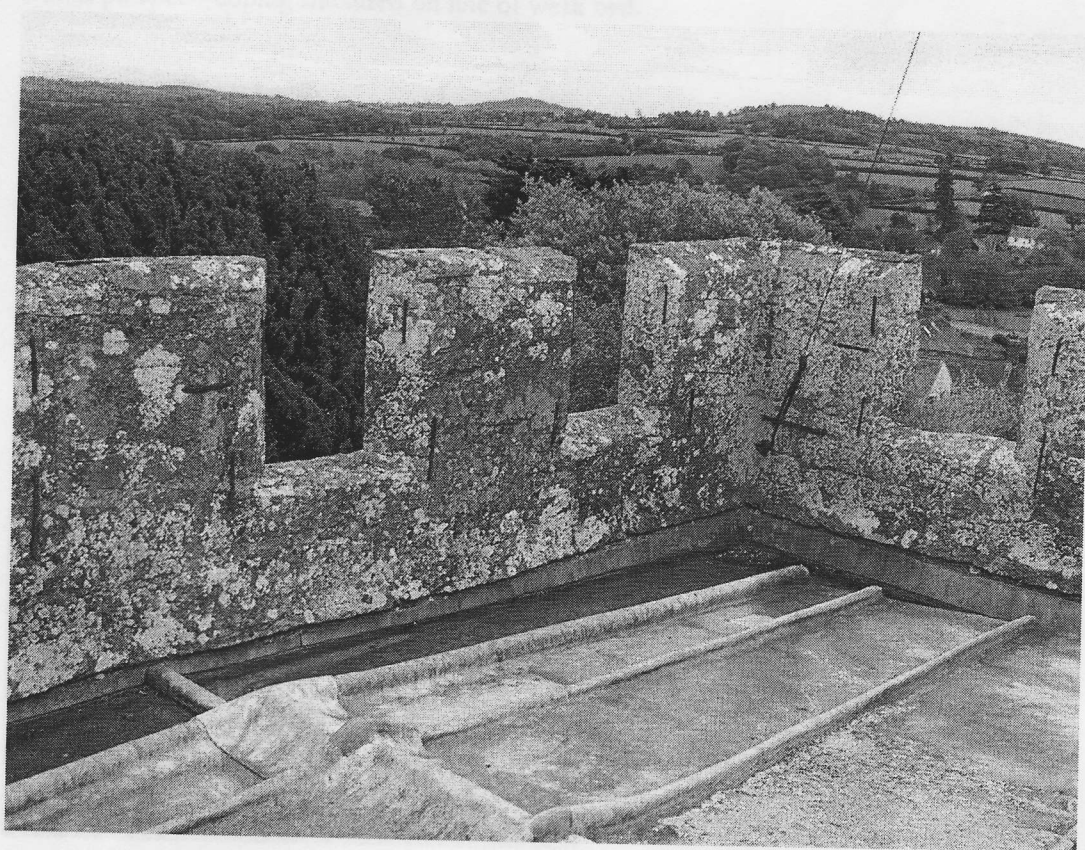
Tower parapet – iron cramps.

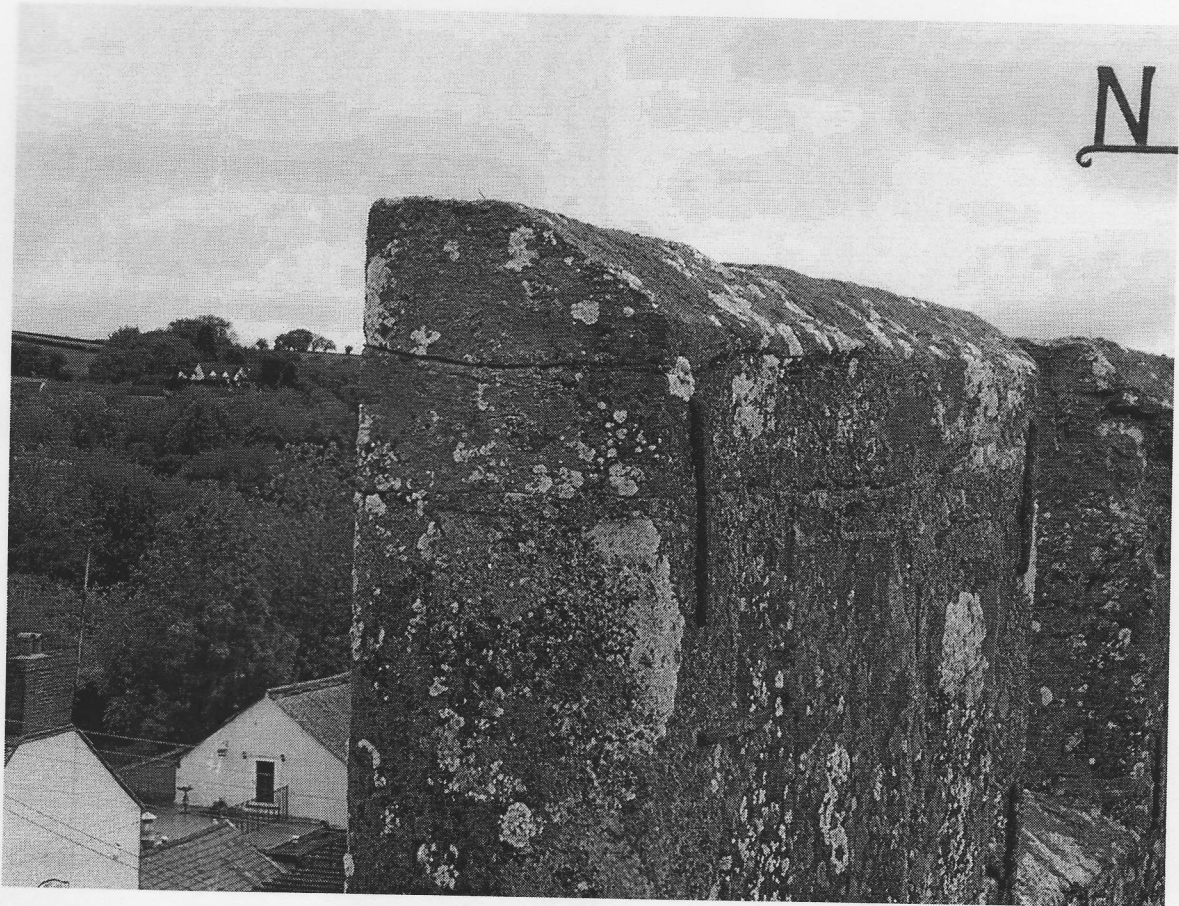
Tower parapet – coping fractured on line of weak bed.

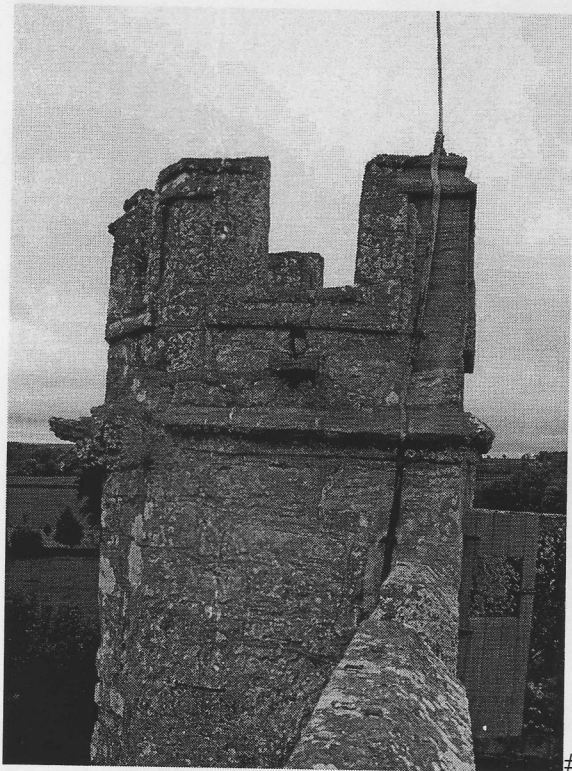
- 5.3 Pointing on the external face of the parapets is also of cement and there are many open joints. In some areas the cement is coming away. Fracturing is occurring through the parapet on the south side at the south-east quoin. Some fracturing is occurring in the east face of the tower vice a high level. F3/
C3

Tower vice – open joints at parapet level.

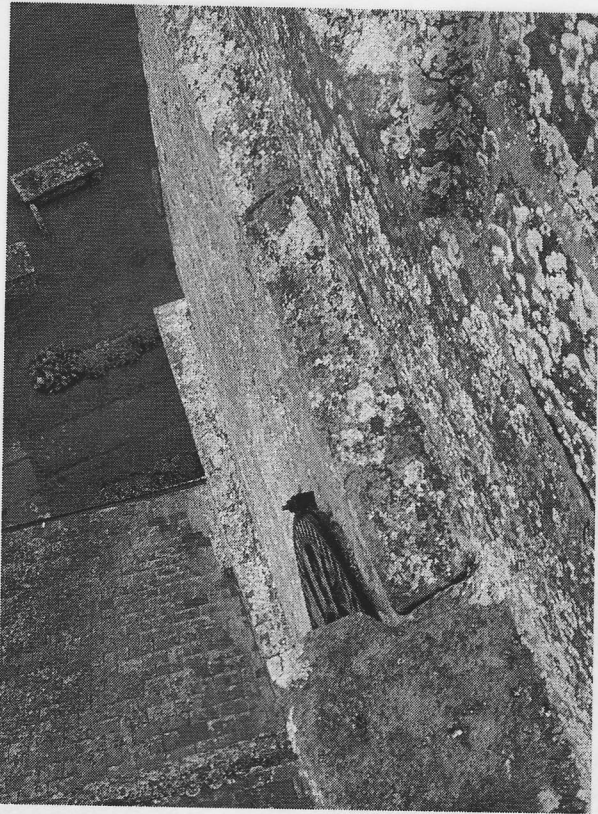
Tower east elevation – open joints in parapet string course.

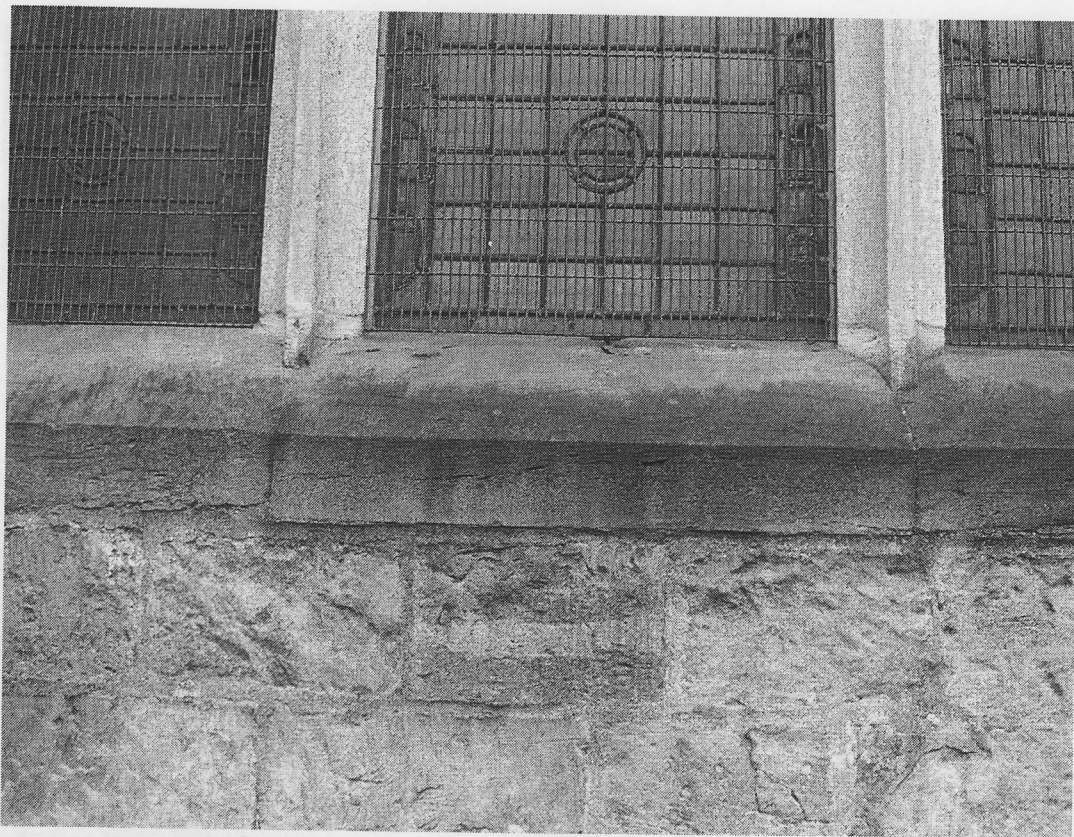
- 8.7 Galvanised guards have been fitted to several windows. Guards which are now rusting and damaging the stonework include: C9

Staining from rusting window guards.

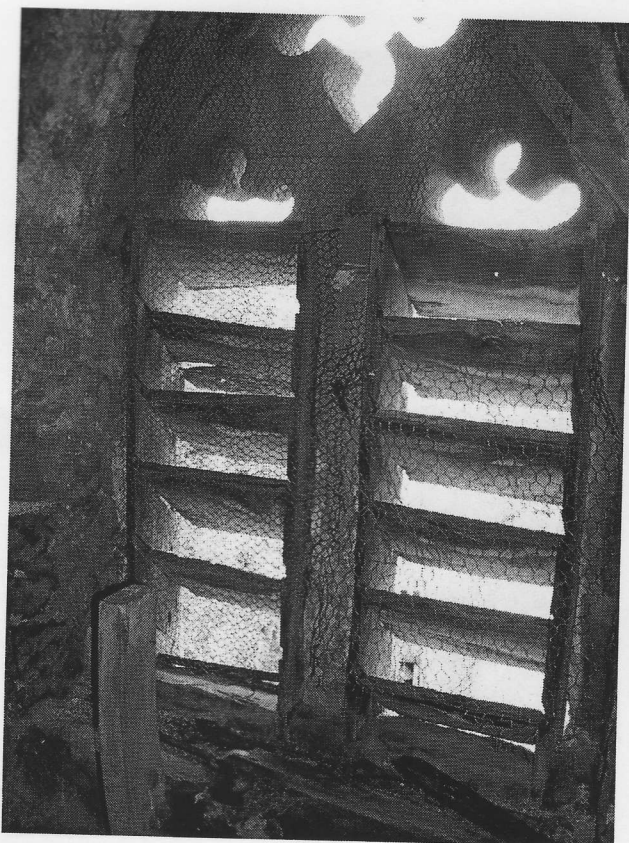
- 10.10 The north, west and south windows all have oak louvres. The condition of these is poor and some of the louver panels are splitting or loose. There is a danger of these falling. A1/
C11

- 10.11 All four windows have been provided with galvanised bird netting previously. However the mesh to the north and west windows is missing and mesh to the east and south windows is in poor condition and holed. Birds (including jackdaws) are gaining entry. The netting should be replaced in stainless steel. A3

Belfry window – guards rusted away allowing bird access. Timber louvres loose.

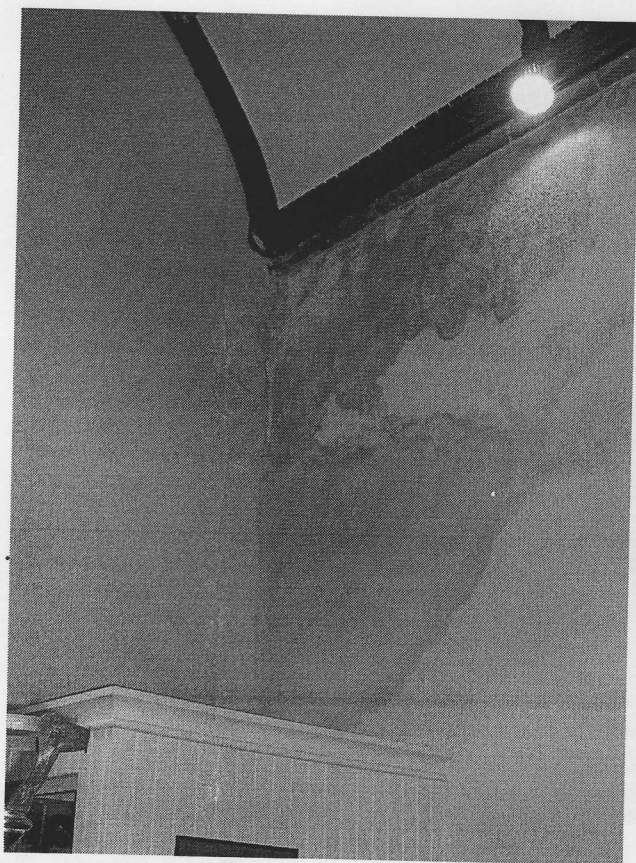
- salt deposition at high level of the western end of the nave north wall and similar staining (although much less severe) at the western end of the south wall. There is salt damage at low level on the south wall east of the porch. Efflorescence is occurring at low level on the west wall, causing breakdown of decorations. Plaster in this area appears to be of dense cement which will tend to trap moisture within the walls.

Nave north-west corner – dampness at high level.

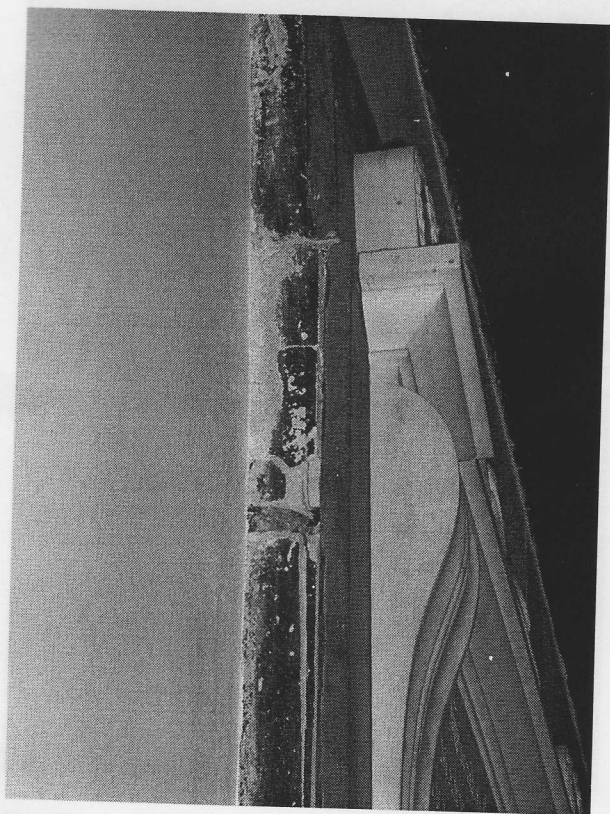
Corrosion of iron cramp causing separation of sections of monument from the backing.

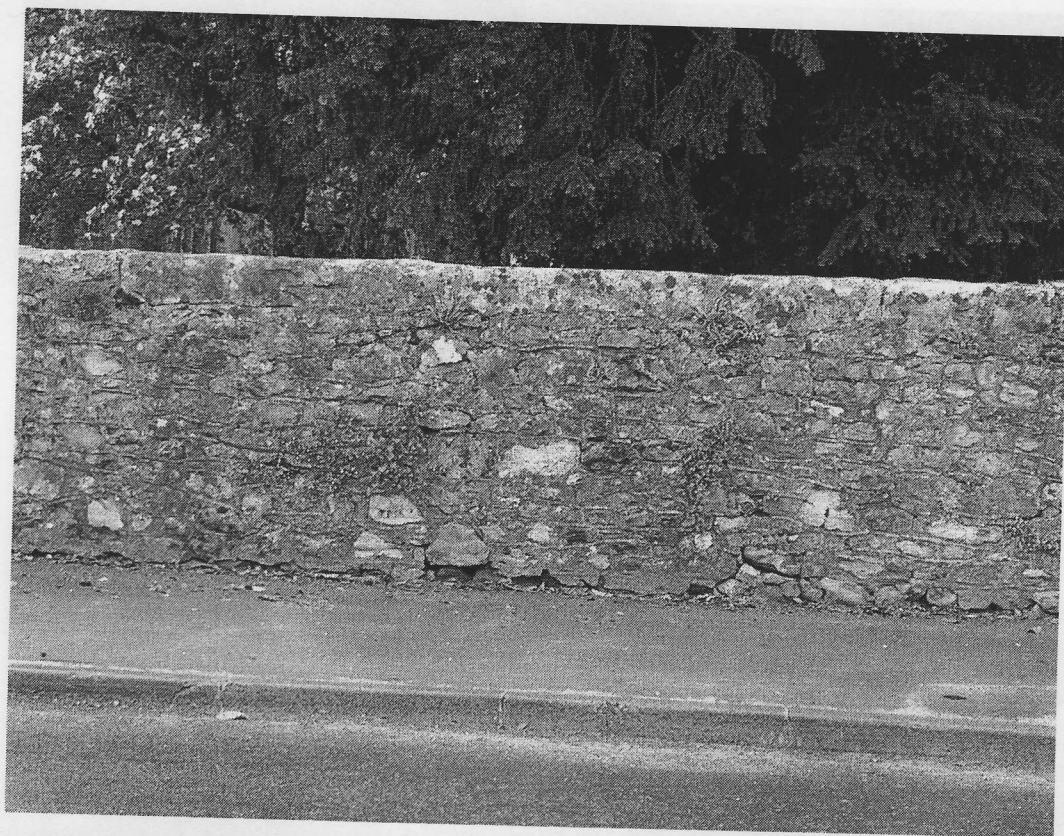
East boundary wall – open joints, particularly at low level.

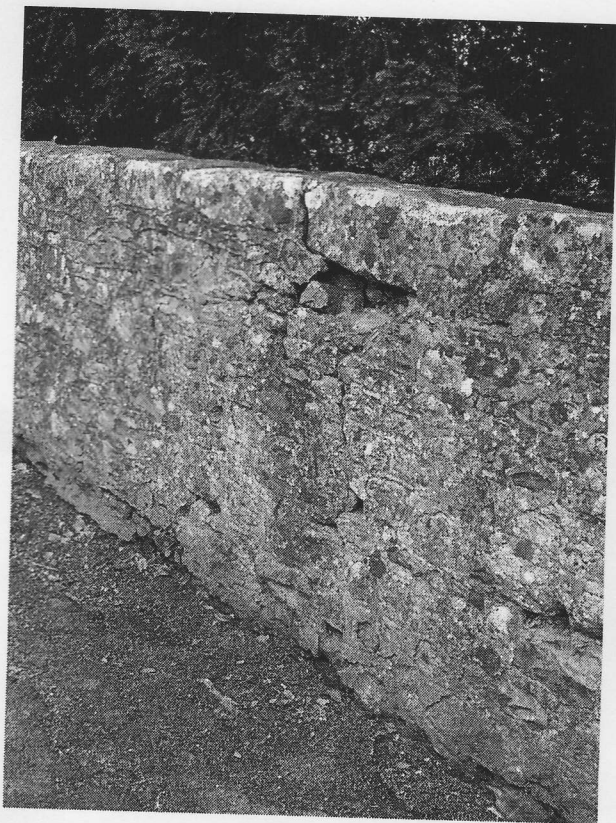
North boundary wall – loose/missing stonework and open joints.

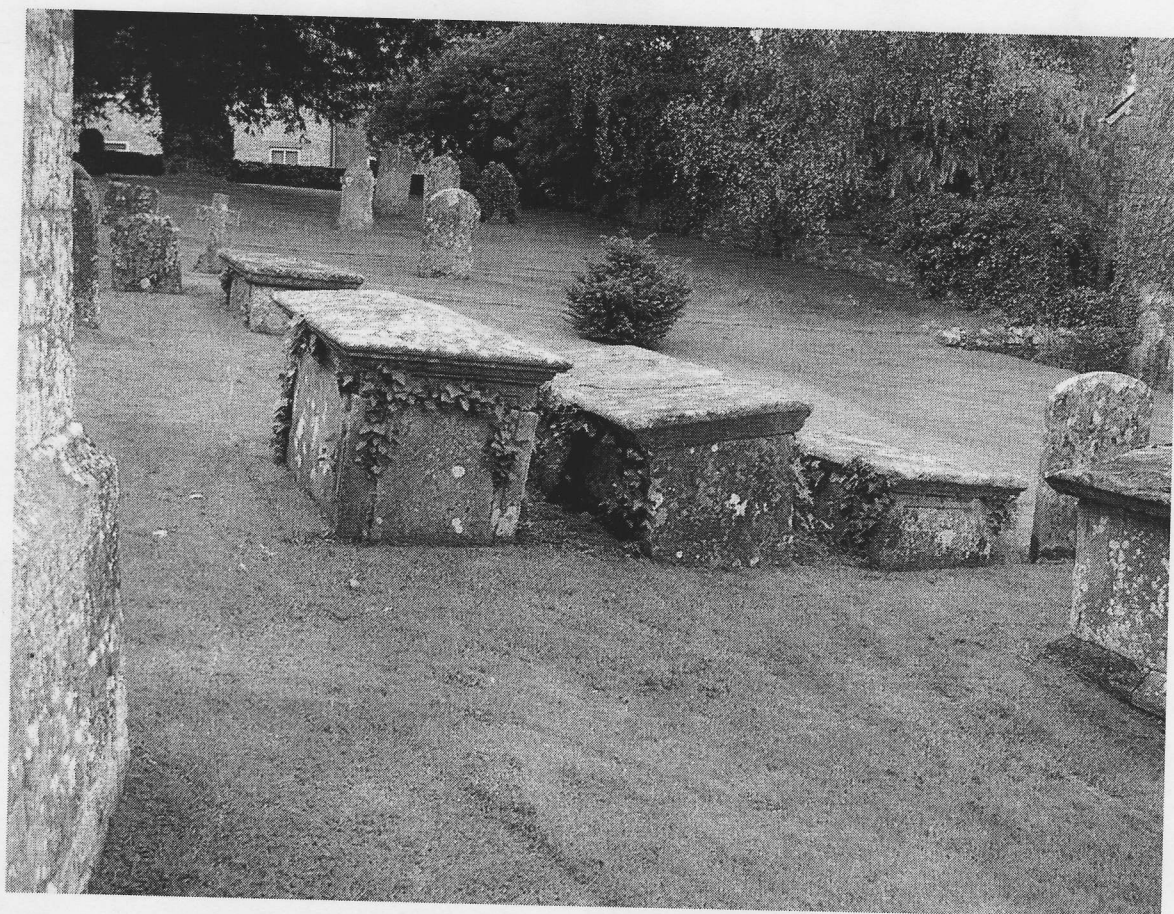
Table tomb – ivy growth needs to be poisoned.
