Report on Investigation Works undertaken at St. Stephen's Church Winsham

July 2008

Report on Roof Investigation Works at St. Stephen's Church, Winsham undertaken in March 2008

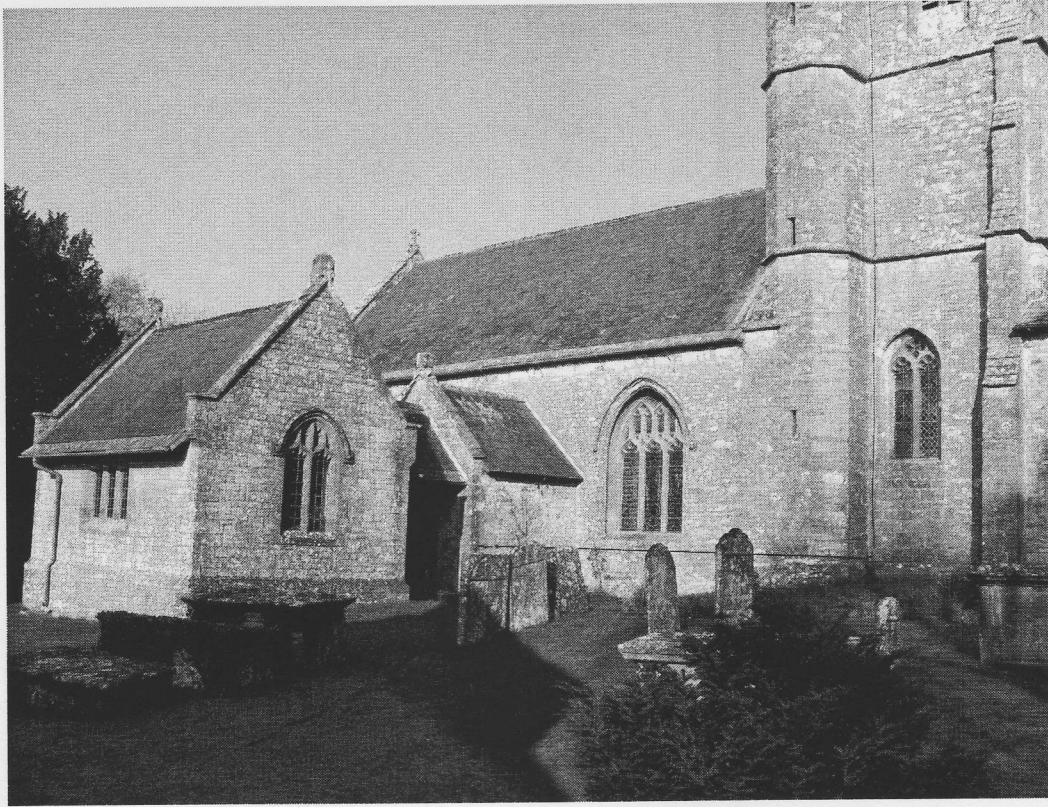
View of nave roof viewed from south-east vestry building in foreground

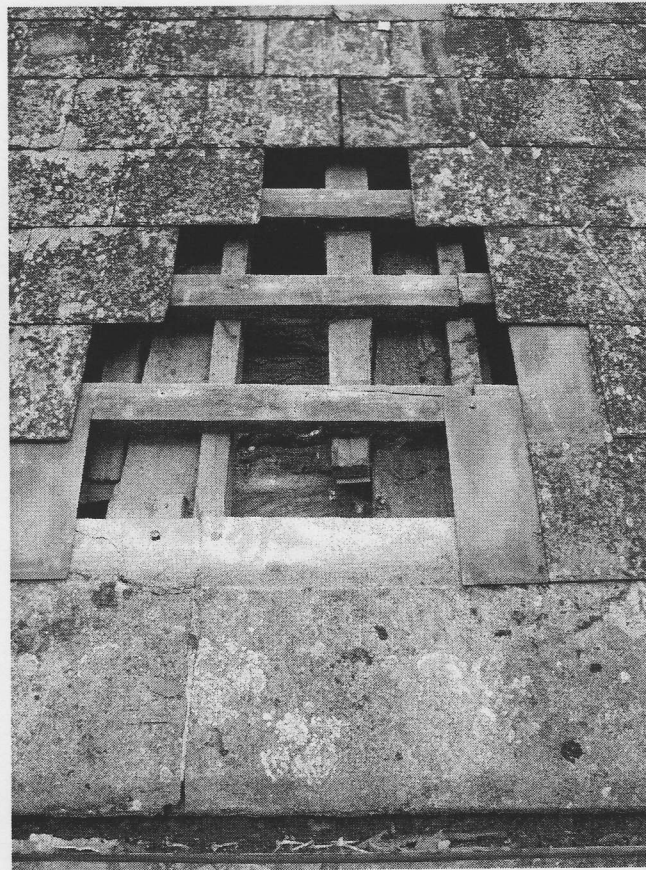
Opening up of roof coverings on south slope of nave. Eaves stones and splint repairs to rafters visible.

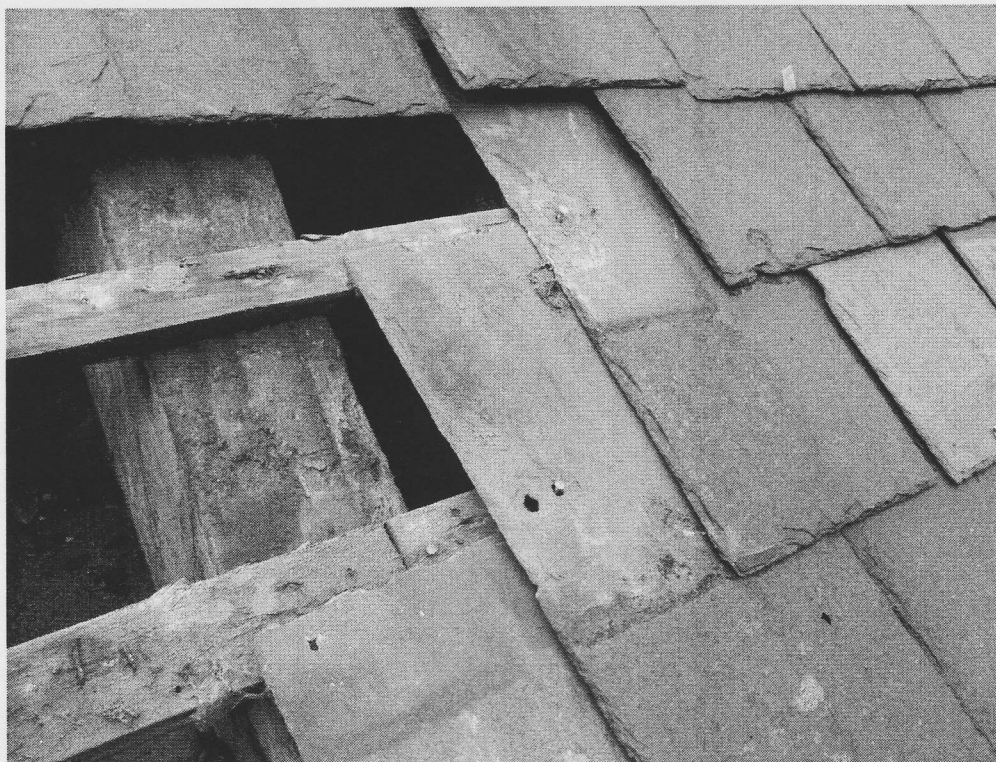
Slates on nave roof fixed to large battens. Poor nail fixing and reholing of slates (for reuse) visible.

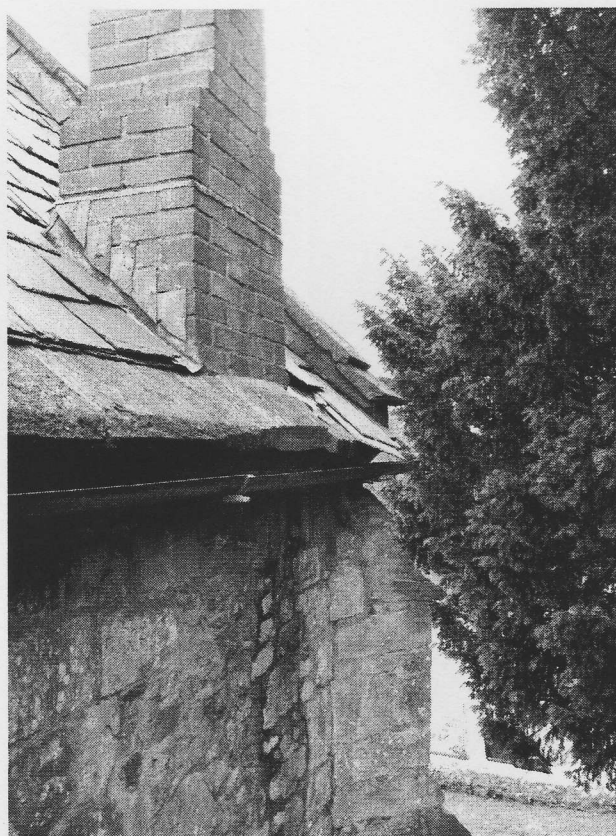
Slipped slates (to right of chimney) at west end of north roof slope. Lead tingles visible above chimney, forming new fixings for previously slipped slates. Water staining visible on wall where roof coverings have failed.

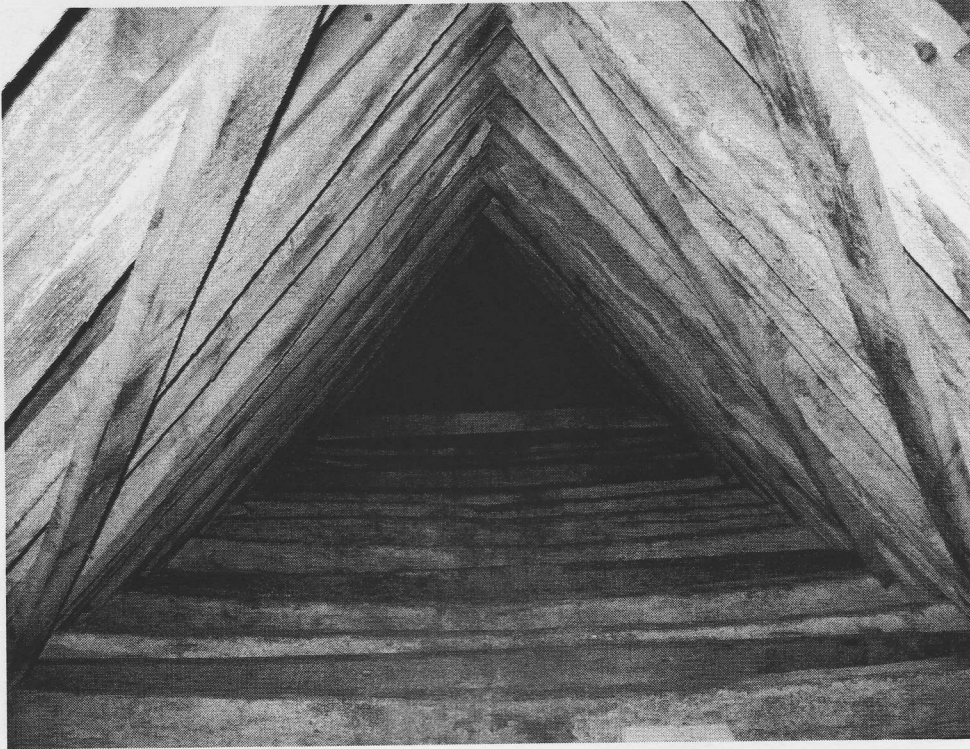
Nave roof void, collars and common rafters visible

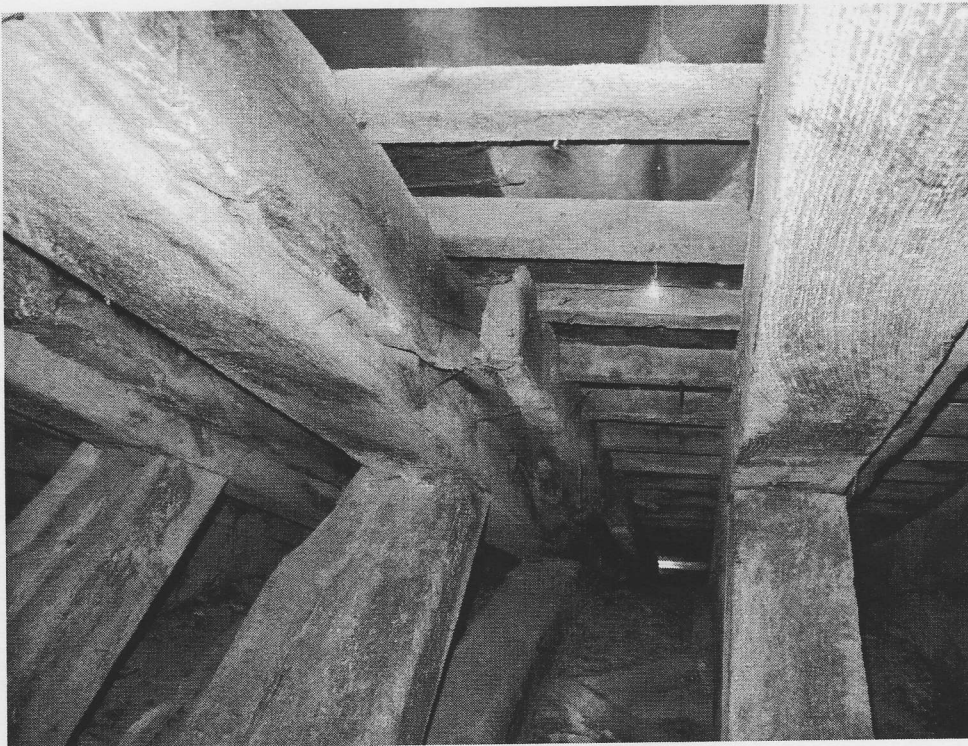
View of common rafters, collars braces, roof battens and underside of slates and top of lath and plaster ceiling looking down from collar level. Splint repairs to rafters visible.

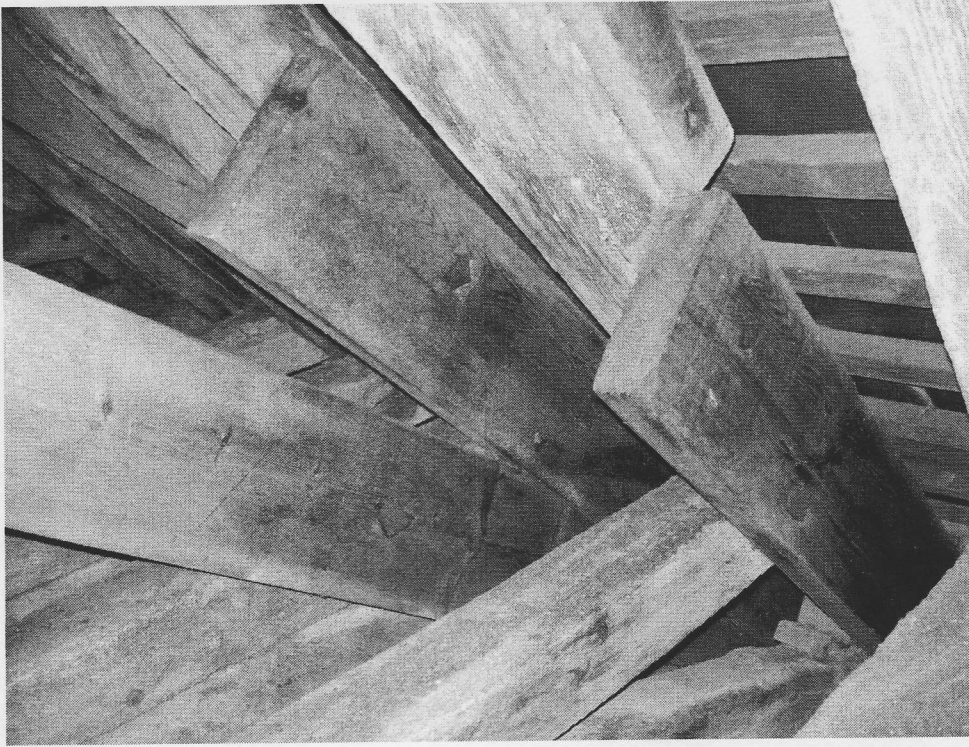
Access to the full length of the roof void above the collar level provided limited views down to the wall plate (over the plaster ceiling) and access throughout the roof, allowed close inspection of the top section of the rafters, the upper braces, collars and ridge connections. Extensive beetle attack and decay were identified throughout all the roof structure elements including the inner and outer wall plates, rafters, collars and braces. Extensive repairs (generally in the form of timber splints) had been undertaken in what appeared to be several phases of repair. A number of the repairs seemed crude and had failed or suffered from beetle attack. While the structure currently appeared to be performing adequately this is significantly aided by the extensive repairs (several of which are now beginning to fail due to the beetle attack) but numerous pegged joints have failed or fractured and the numerous areas of decay have caused isolated areas of weakness. The original roof structure is of oak and the majority of repairs are formed in softwood. A significant number of the trusses are racking to the west.

Extensive splint repairs to nave roof structure. A number of the splint timbers are now suffering from beetle attack and decay.

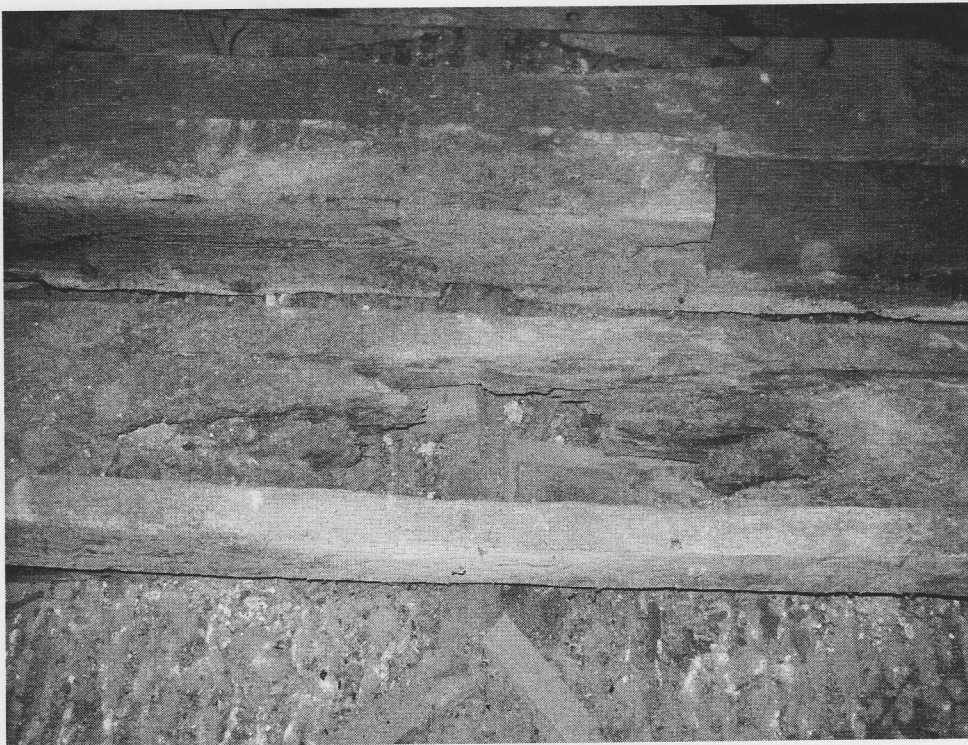
Severe decay to elements of the roof structure previously repaired.

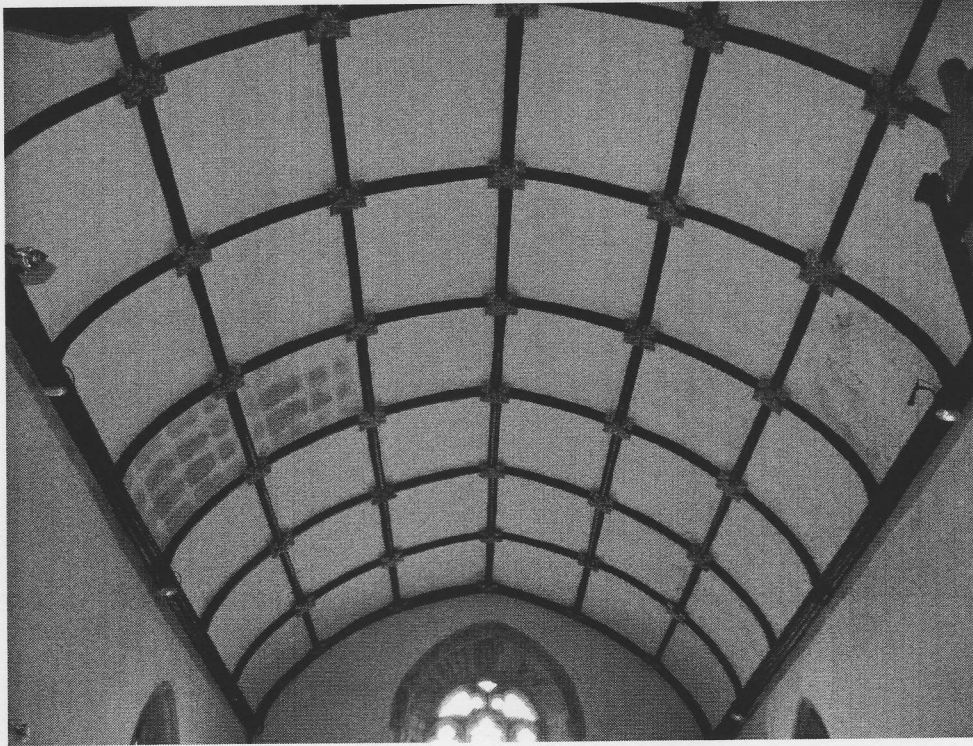
Internally the nave has a barrel vaulted lath and plaster ceiling to its full length. The lath and plaster is fixed to timber braces fixed directly to the underside of the roof trusses (see roof structure above). The fixings of the laths were not visible during this inspection. The laths are much newer than the original roof structure and generally appear to be well fixed and in good condition. A small number of laths have minor decay (generally in areas of leaks) or damage. In a few areas the plaster key has failed, although this is generally sound where visible. The ceiling is decorated with what appears to be a casein bound distemper. Internally, the plaster had a number of stained patches which appear to correspond with previous leaks through the roof coverings. There is some damage to the plaster in these areas.

Nave ceiling showing moulded rafters and horizontal ribs (fake purlins), carved bosses and staining/damage to plasterwork due to water penetration through roof coverings.

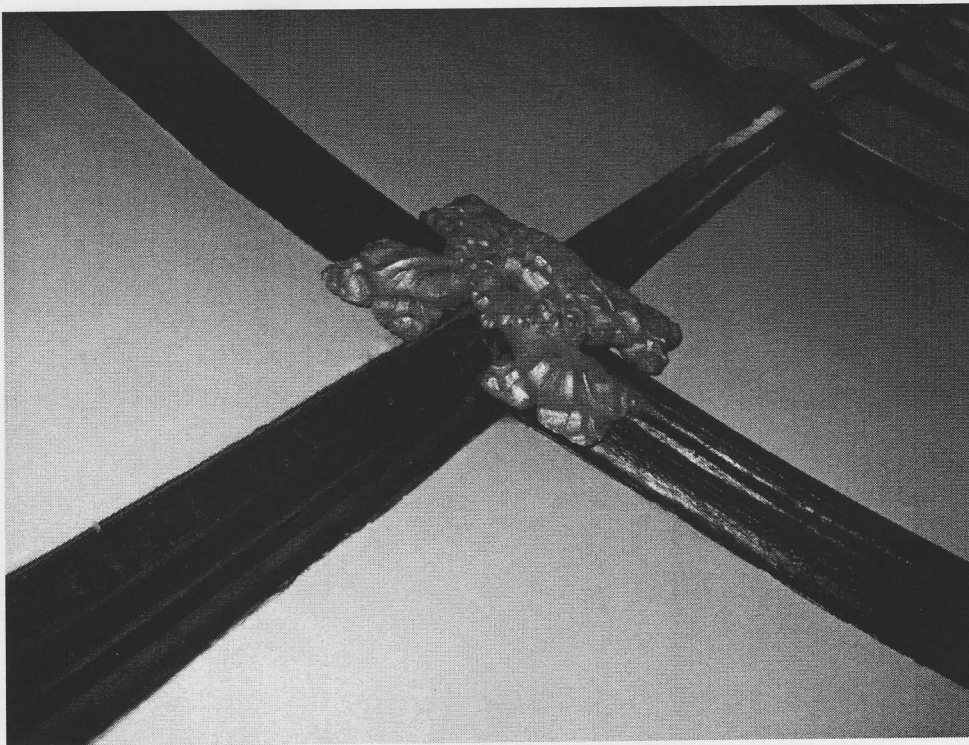
Carved boss screw fixed to moulded rafters and horizontal ribs (fake purlins).
